# FACILITY COMPLIANCE INSPECTION REPORT

# Division of Waste Management Solid Waste Section

Date of Site Inspection: September 12, 2013 Date of Last Inspection: August 11, 2011

Harnett/Dunn-Erwin C&D Landfill 449 Daniels Road Dunn, NC 28334

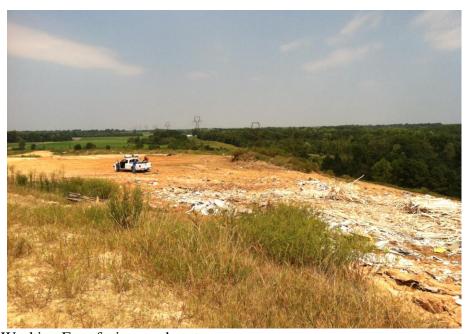
- 15. The waste type being accepted into the landfill is construction and demolition waste only.
- 16. The working face was less than one half acre and was being compacted during the inspection.

Working Face facing northeast.

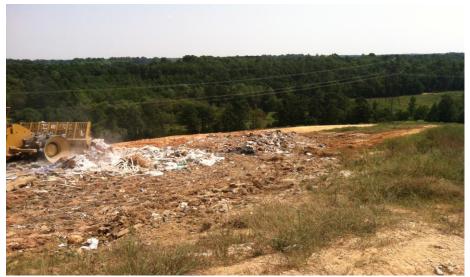
Working face facing east.

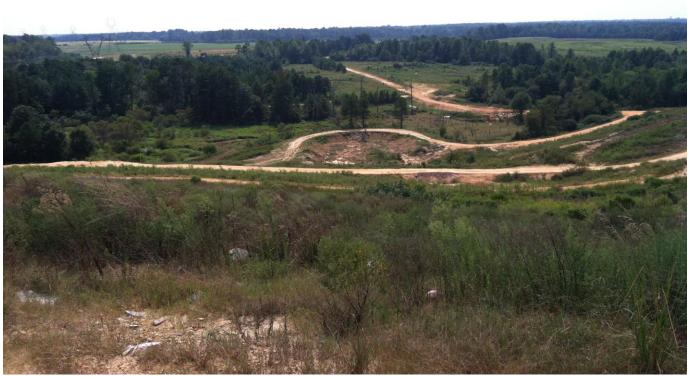
Top of CDLF facing south upstream of sump

- 17. The leachate breakout area has been repaired and cleaned up.
- 18. The leachate sump was reviewed. In addition to the sump the leachate collection sub surface slope drains were reviewed. I would recommend providing additional cover upstream of the sump
